## MEMORANDUM

**Project:** 090557-01

**Re:** Post-TCRA Quarterly Inspection Report - January 2013 Inspection

This document reports the results of the January 2013 quarterly inspection of the armored cap cover, fencing, and signage installed for the Time Critical Removal Action (TCRA) at the San Jacinto River Waste Pits Superfund Site (TCRA Site).

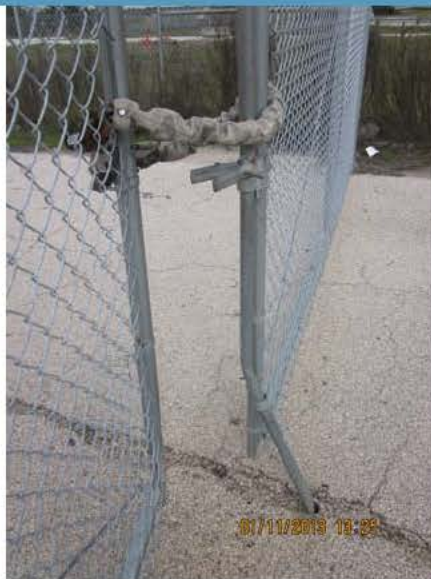
The visual inspection event on January 11, 2013 did not identify damaged or otherwise deficient areas in the perimeter fence or signage. Incidental damage to the fence center post at the eastern gate was noted, but did not require action, as it was not identified as a breach in the fencing. However, additional inspections of the TCRA Site fencing during the armored cap survey and maintenance event identified two breaches in the perimeter fence. These two areas were repaired by the Respondents' Fence Contractor; all repair activities were completed by February 6, 2013. Details regarding the TCRA Site fencing repairs are provided in the attached Maintenance Completion Report; see photographs 26 through 28 of Appendix A for examples of the fencing repairs.

Photo 05: Bent center post of east access gate (view east)

Photo 28: New gate center post installation, east bank (view north)

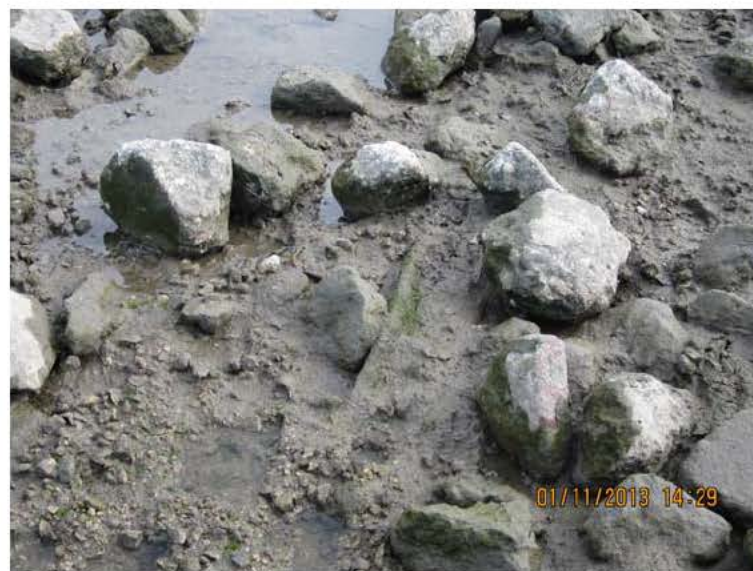
There was a low tide during the January 11, 2013 visual inspection because of northerly winds. This low tide exposed two localized areas of the TCRA armored cap cover with less than 12 inches of stone cover thickness. The underlying geotextile layer in those areas was intact and there was no evidence that any of the underlying materials were or had been exposed. The USEPA was notified of this condition through a phone conversation and submission of a notification letter on Tuesday, January 15, 2013. The Respondents conducted a field investigation during a low-tide event on Thursday, January 17, 2013 collecting topographic and probing data that identified three additional areas that had less than 12 inches of stone cover thickness and would require maintenance. One of the three additional areas also required geotextile placement over an approximate 2 foot by 2 foot area. Further phone communications with the USEPA took place on Thursday, January 17, 2013, and an additional written notification was submitted to USEPA on January 18, 2013. The Respondents continued to evaluate the TCRA cap during the low tide conditions that existed on January 17 and January 18, 2013. The low tide event on Friday, January 18, 2013 was the lowest of any of the inspection days, and was at -2 foot mean sea level (MSL)<sup>3</sup>.

Photo 12: Thin armor cap area identified during visual inspection (view north)

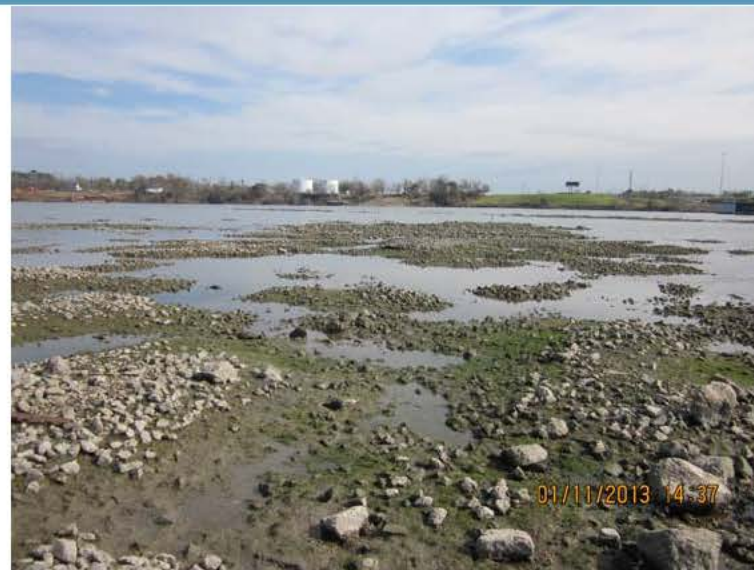
Photo 14: Low tide conditions in the Eastern Cell; note sedimentation and biological growth (view east)

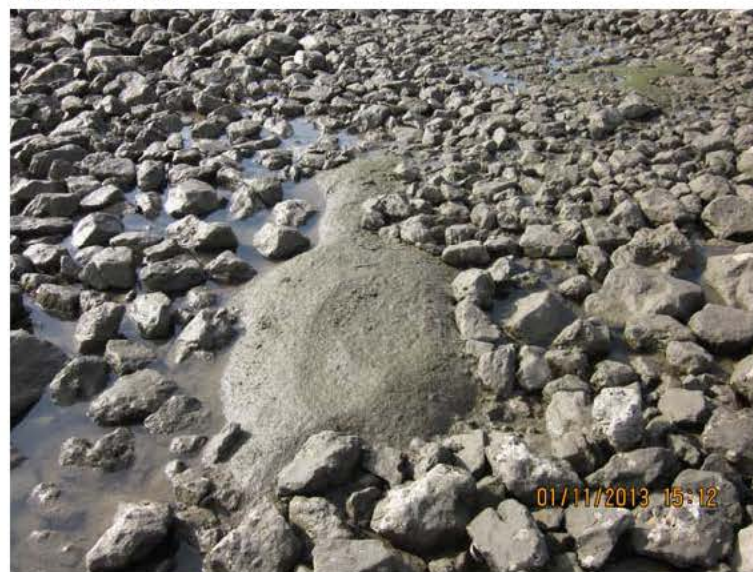
Photo 16: Areas (foreground and background) of thin armor cap area and exposed geotextile identified during visual inspection (view northwest)

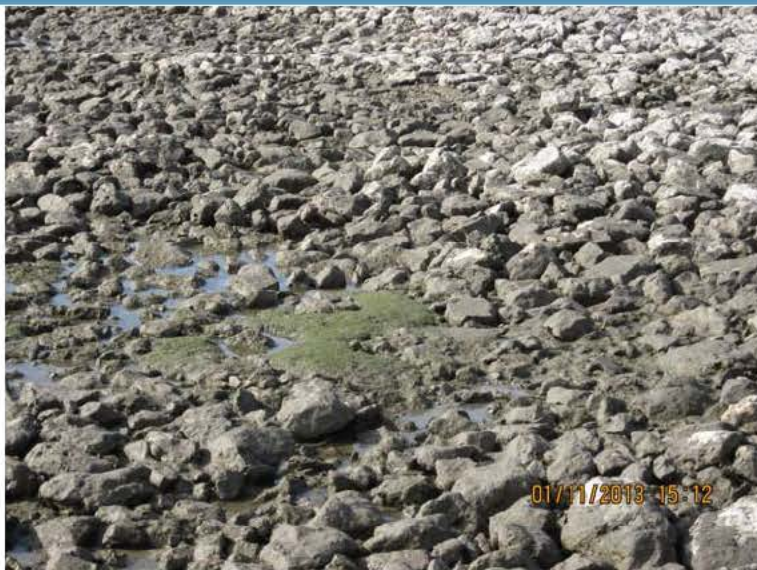
Photo 17: Background location from Photo 16 of thin armor cap area and exposed geotextile identified during visual inspection (view southwest)

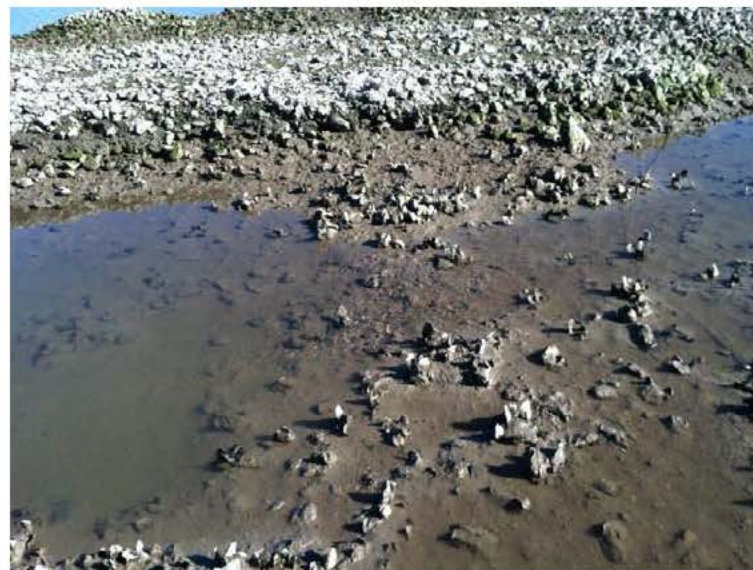
Photo 24: Area of Eastern Cell showing biologic growth and sediment deposition (view northeast)

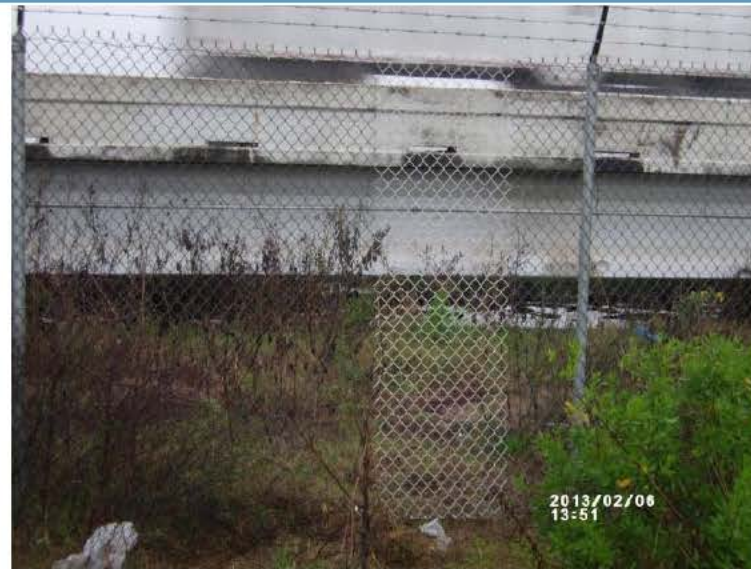
Photo 26: Repaired fence fabric, south alignment, west bank of the San Jacinto River I-10 crossing (view north)

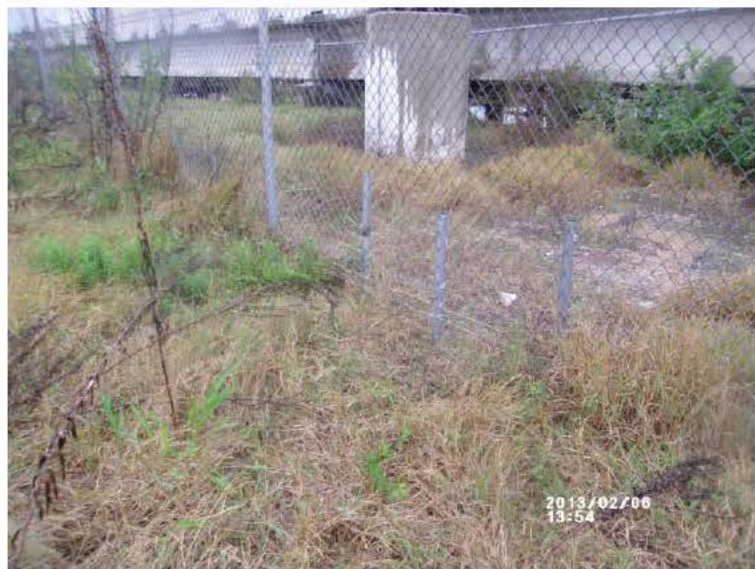
Photo 27: Added lower supports on adjacent panels to secure fence fabric and barb wire (view northwest)

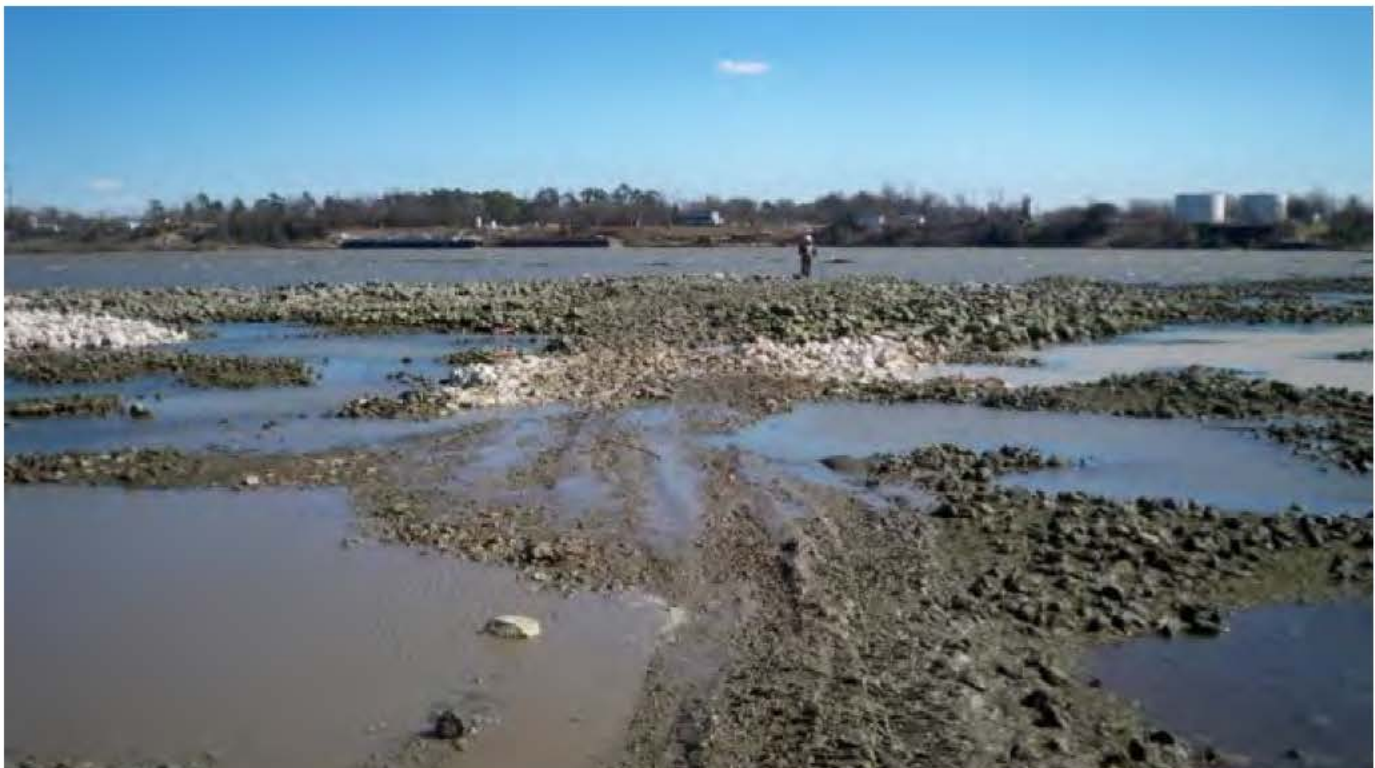
Photograph 1 - Completed MA 2 in foreground, surveyor marking MA 3 in background.

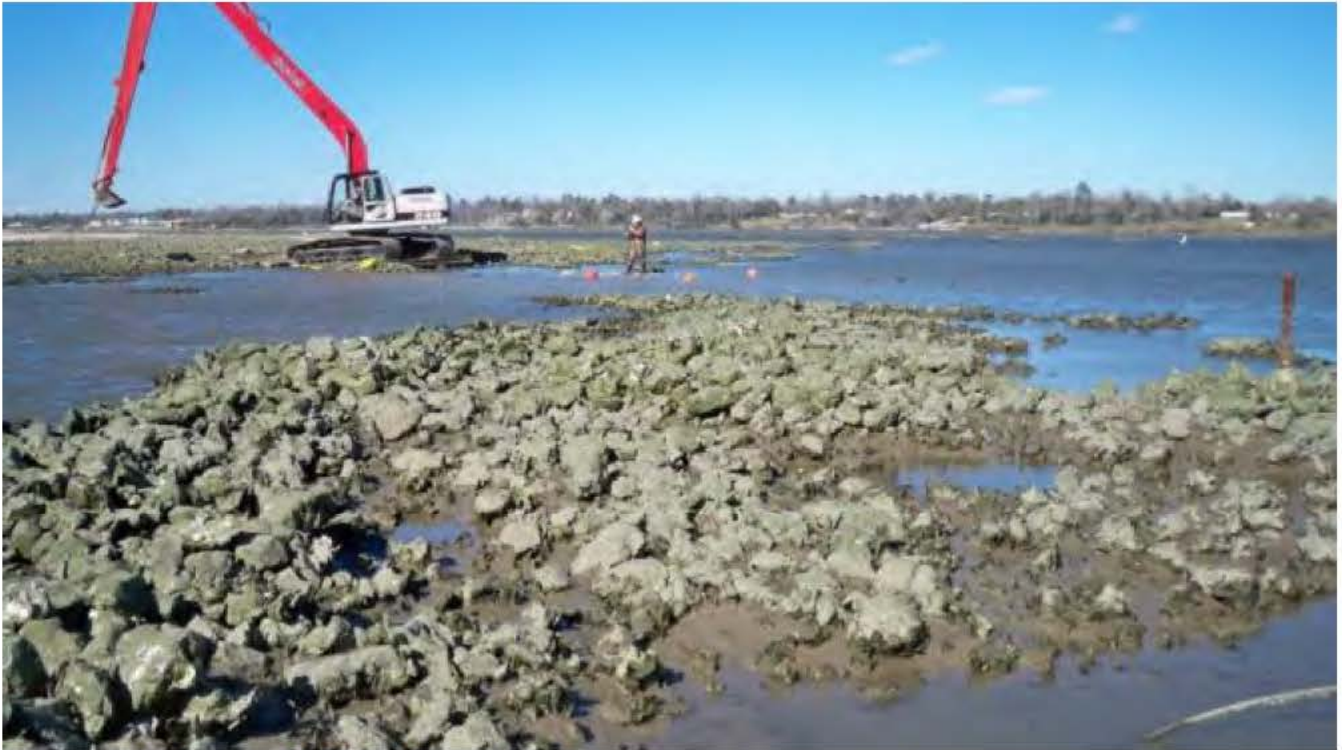
Photograph 4 – Surveyor checking MA 4 surface before demobilizing long reach excavator.

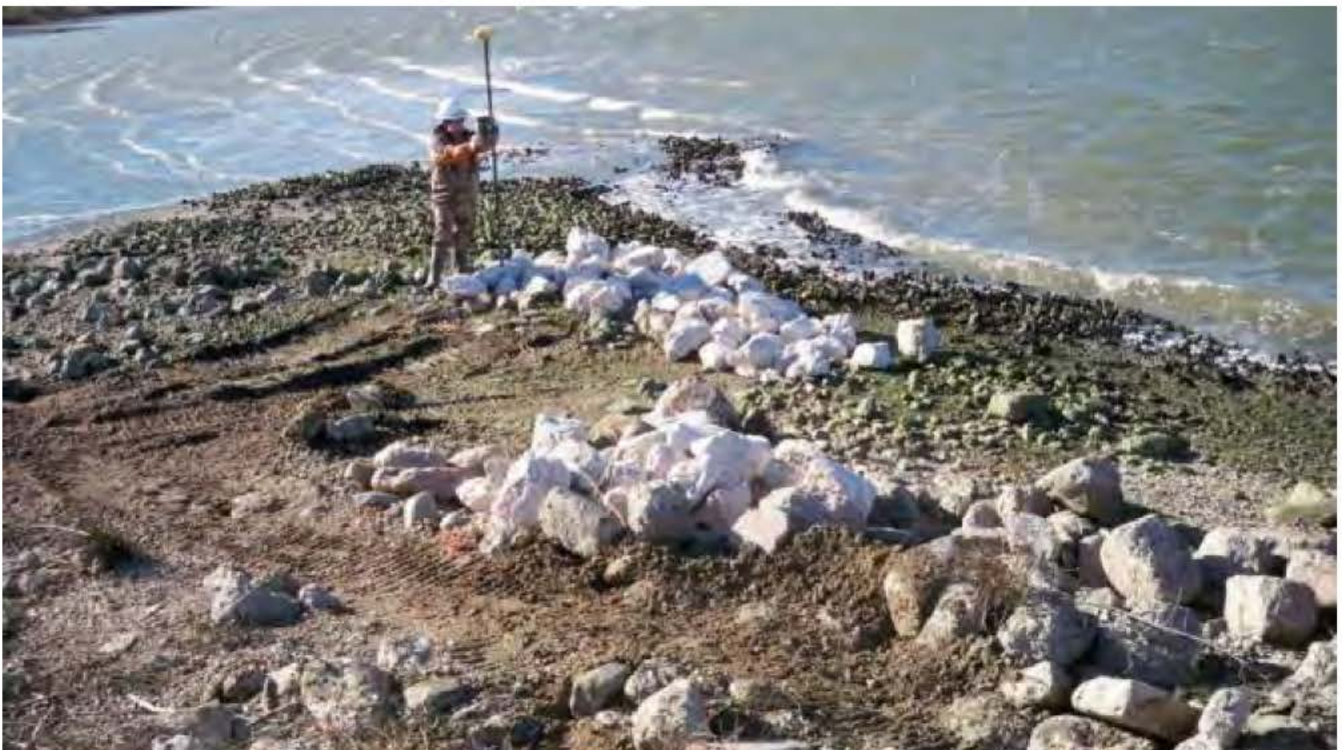
Photograph 5 – Surveyor checking lap joint maintenance, NW corner western flats. Photograph from atop western berm.

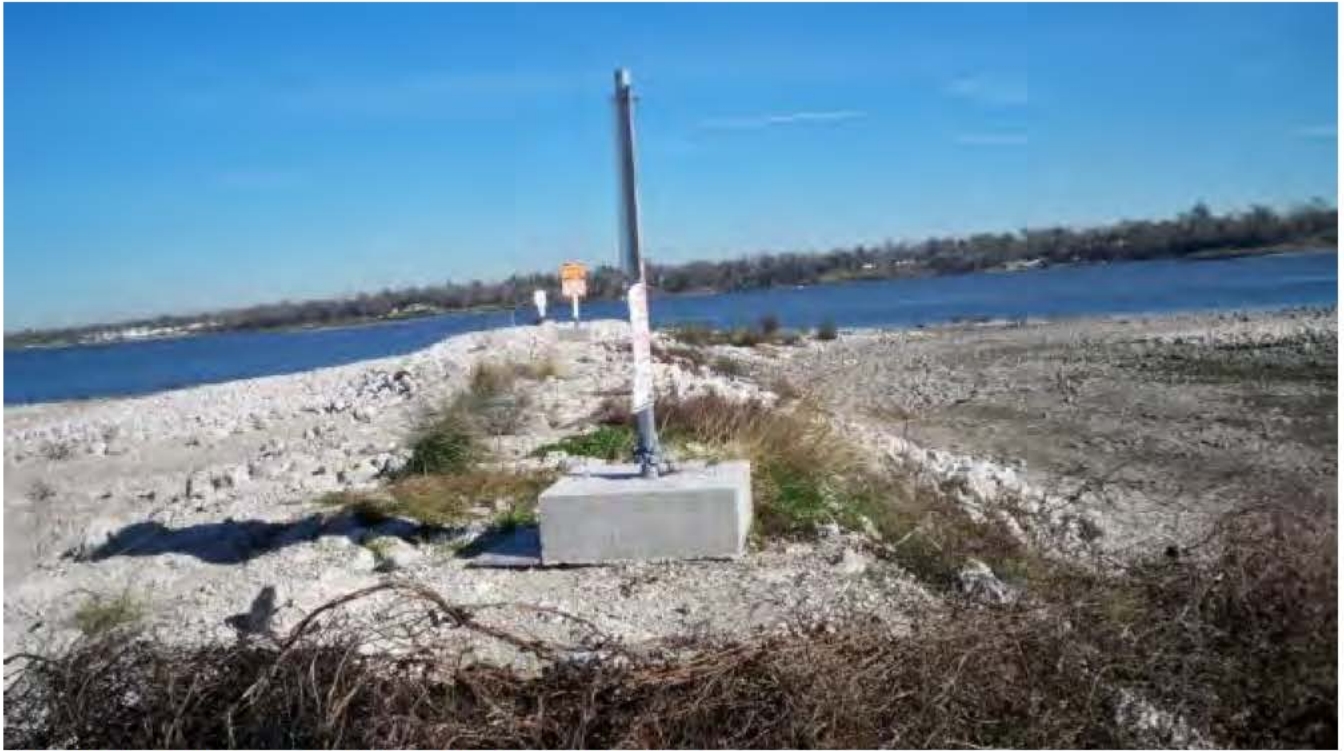
Photograph 2 – Vines removed from signage on central berm.

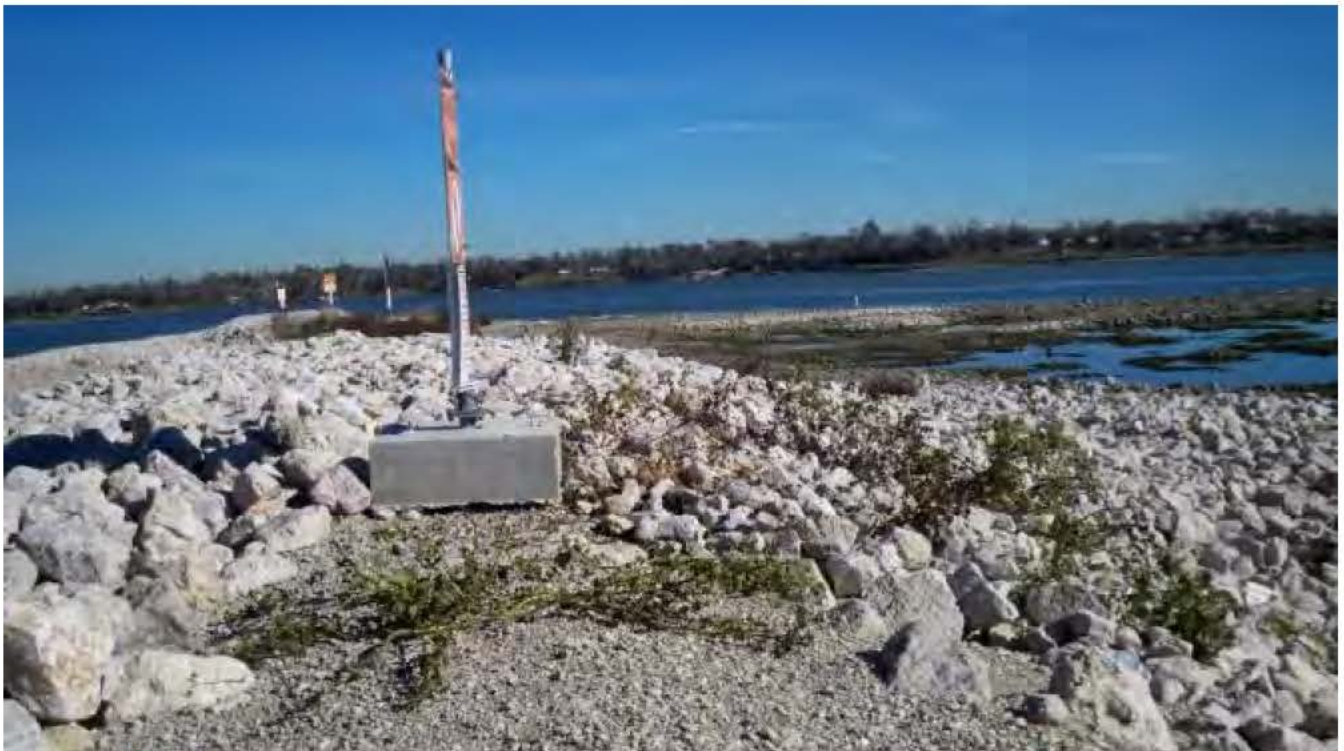
Photograph 3 – Woody stem vegetation cleared from signage on central berm.

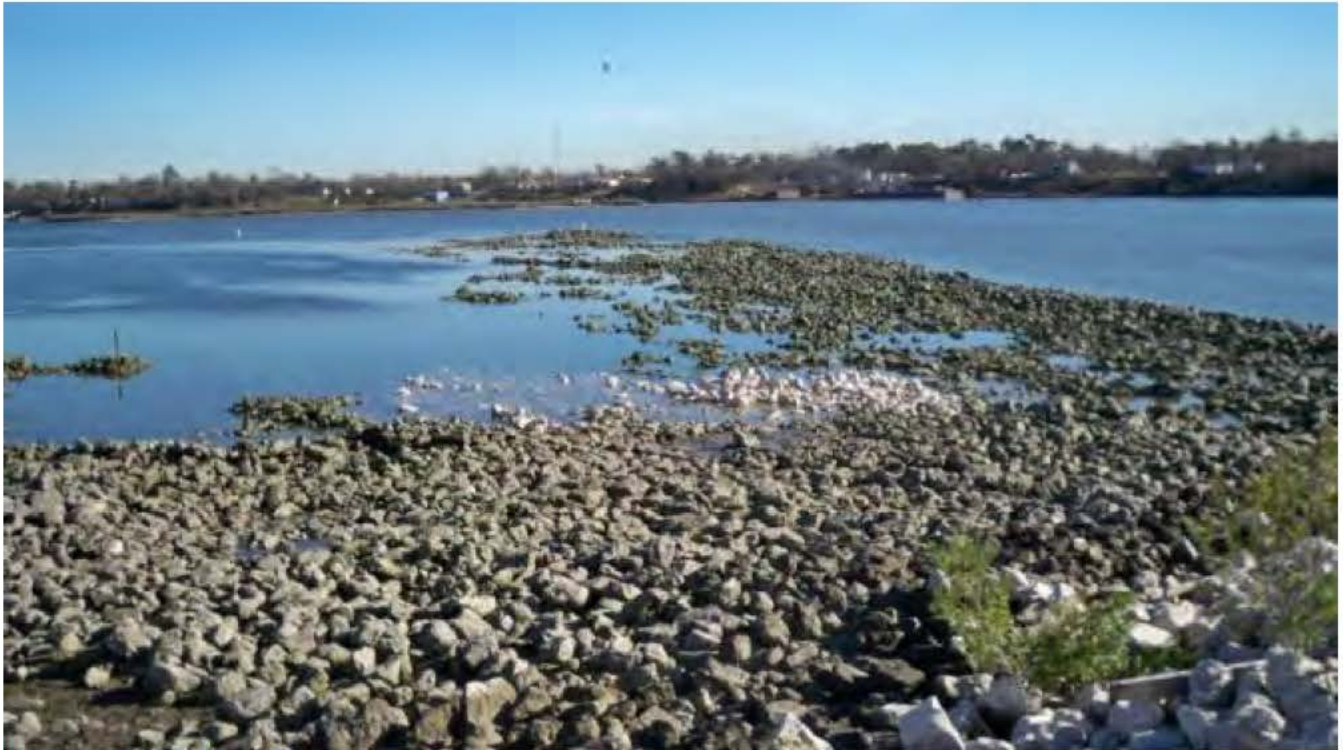
Photograph 6 – MA 5 photo from atop the southern berm.

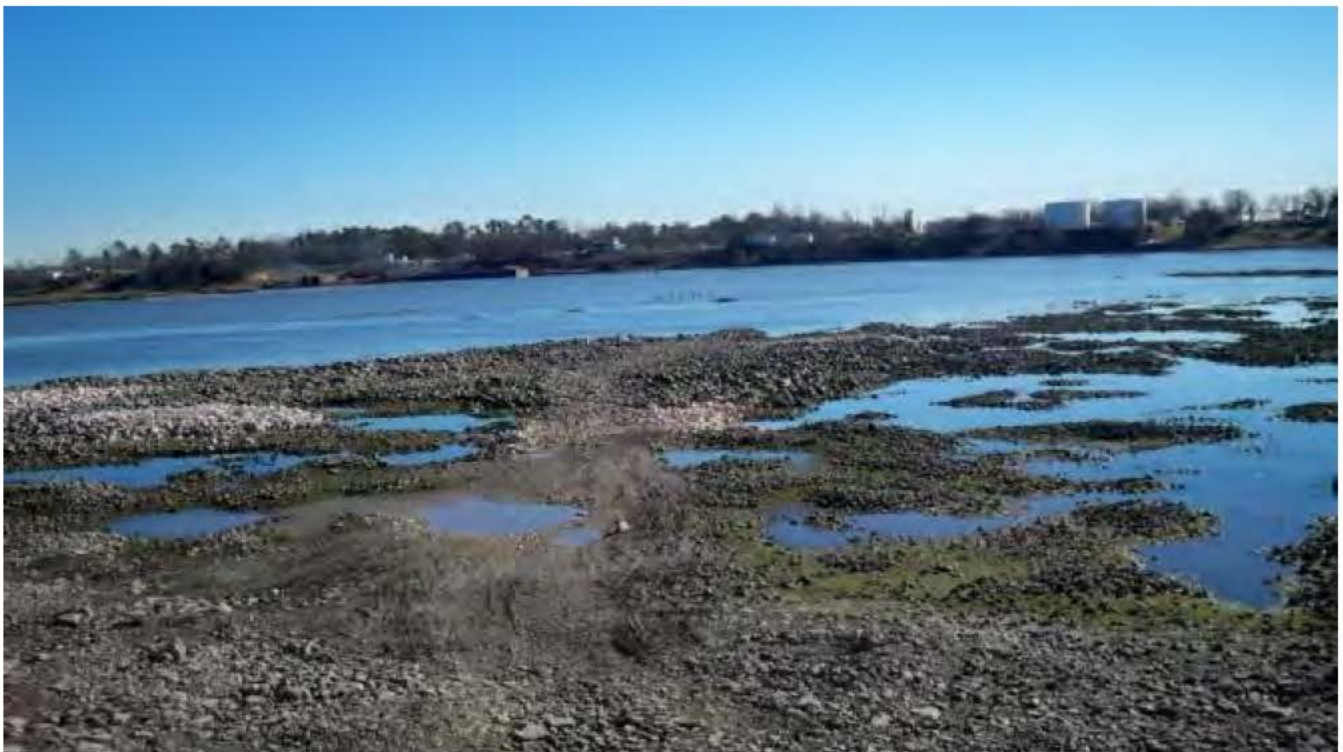
Photograph 7 – MA 1 and 2 and showing access lane to MA 2 and 3. MA 3 in the distance.

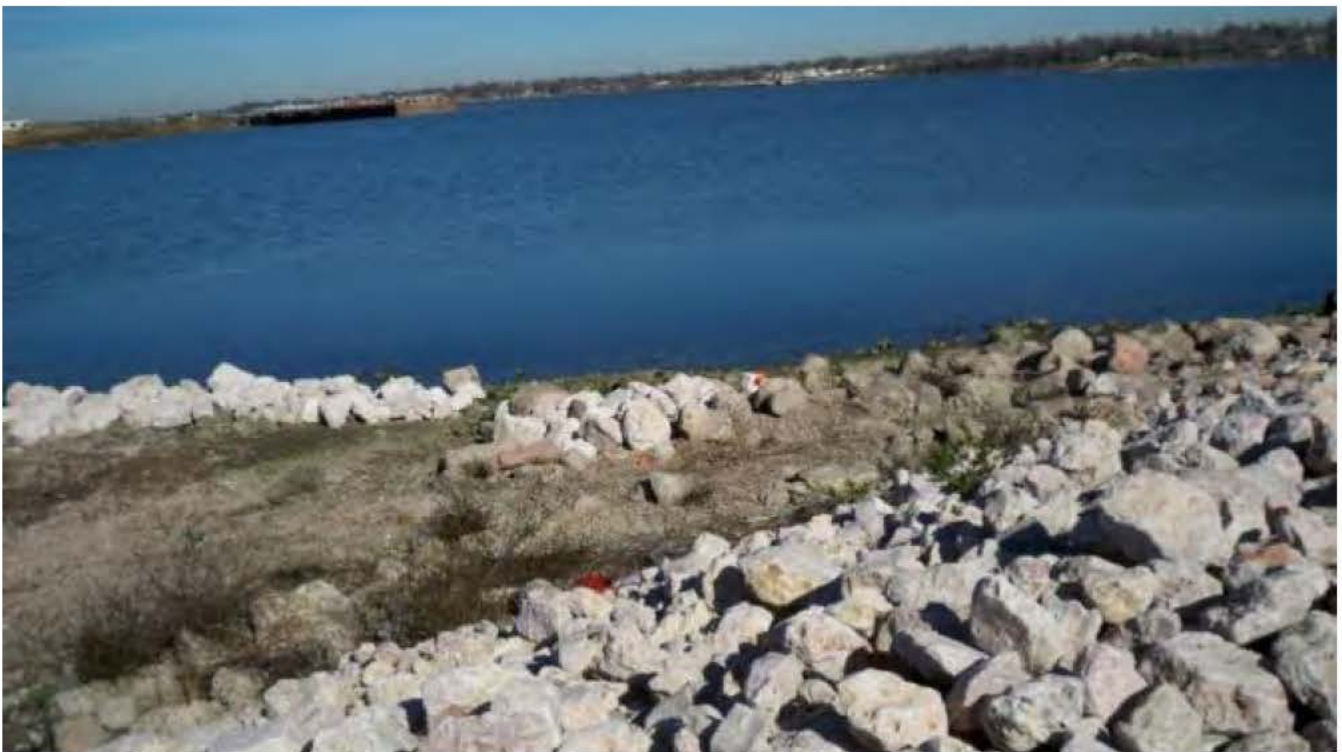
Photograph 9 – From atop the western berm, looking north and east. Small maintenance area near water's edge.

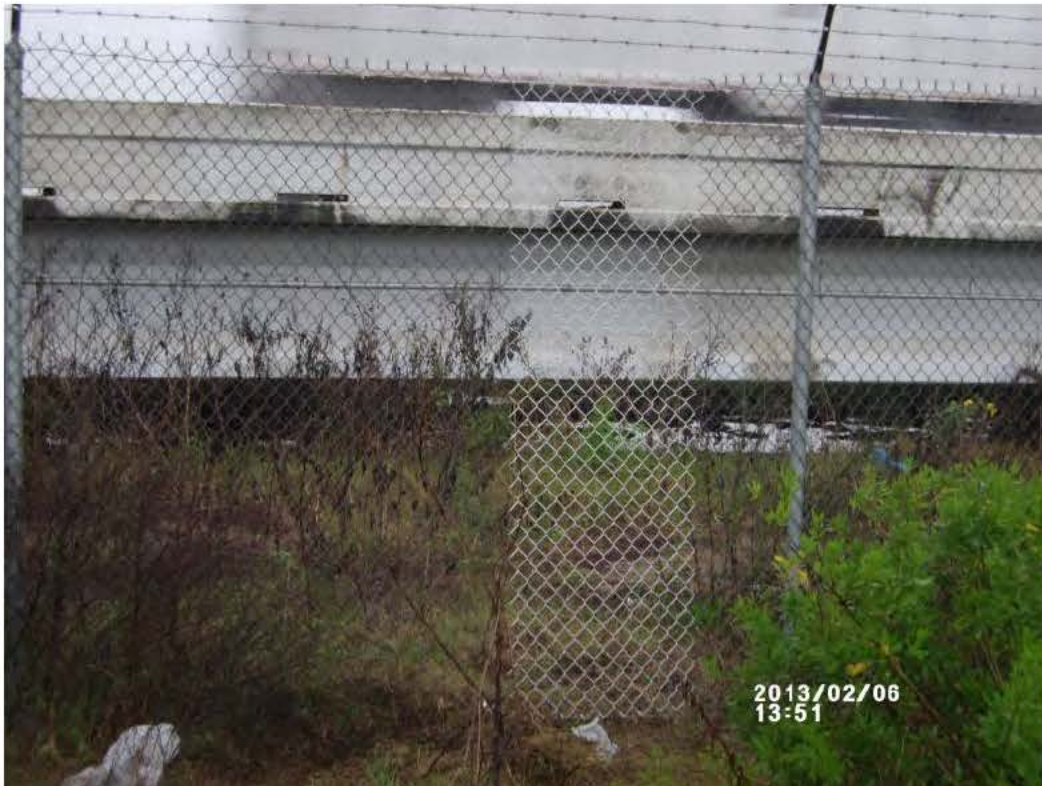
Photograph 1 – Repaired fence fabric, south alignment, west bank of the San Jacinto River I-10 crossing

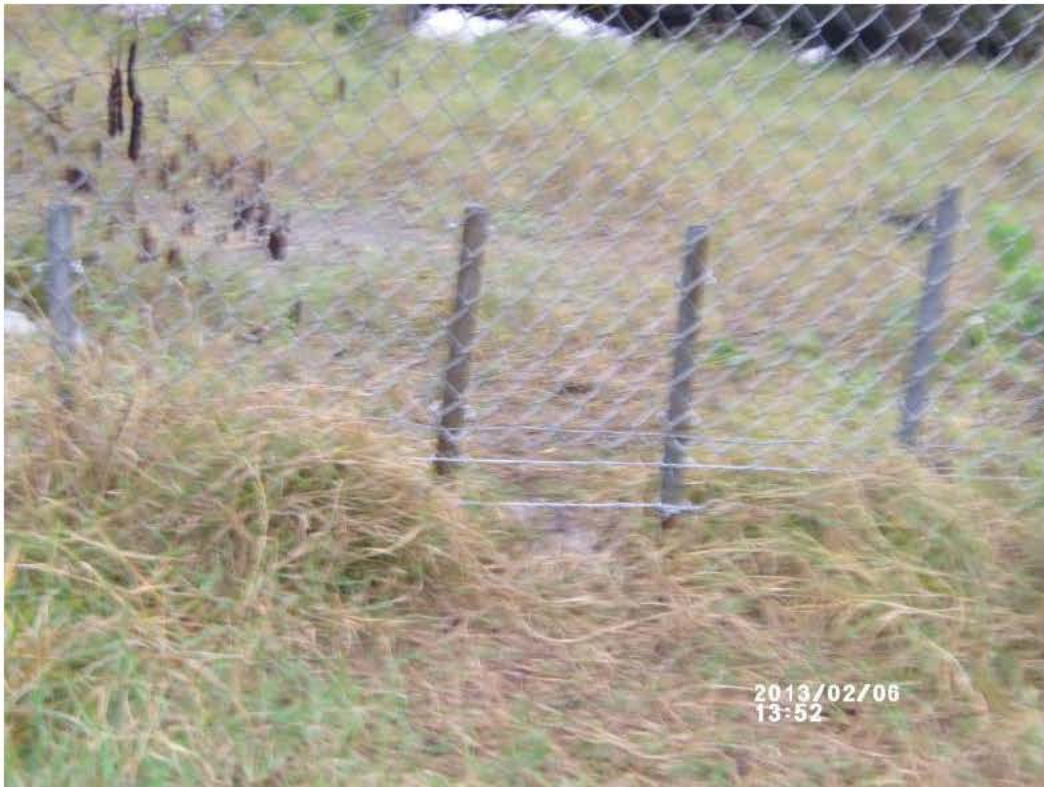
Photograph 2 – Added posts and barb wire closures, south fence alignment, west bank.

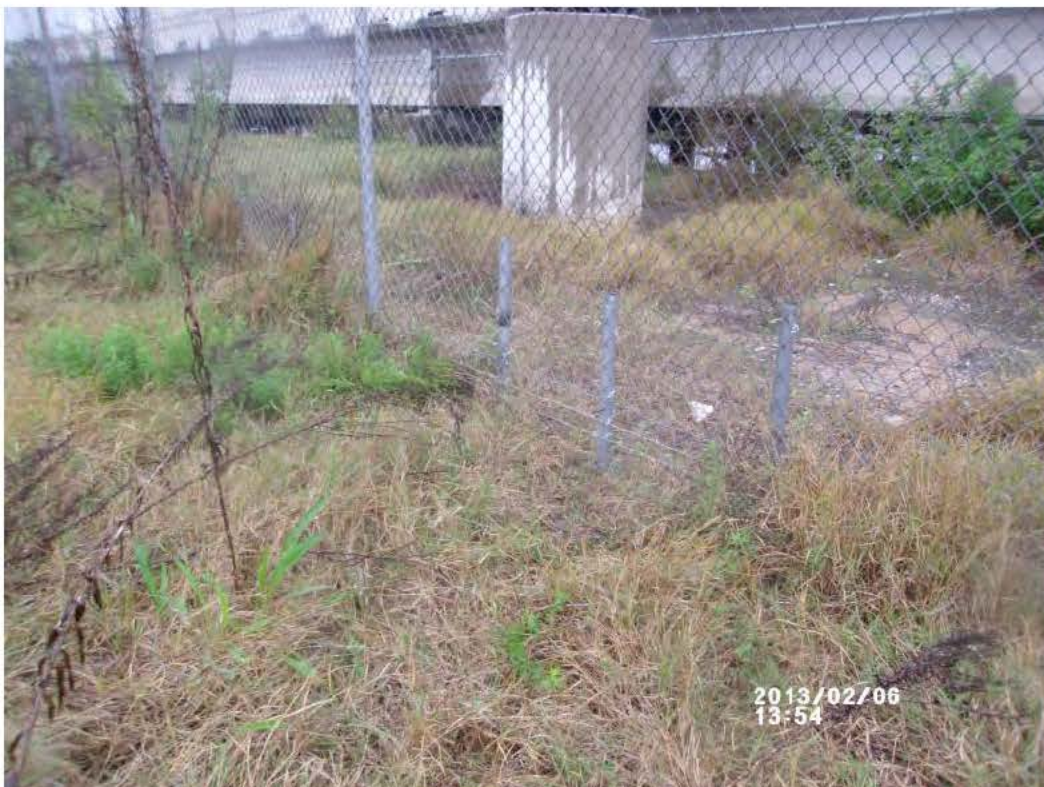
Photograph 3 – Added barb wire and fence supports to prevent access, south fence line, west bank.

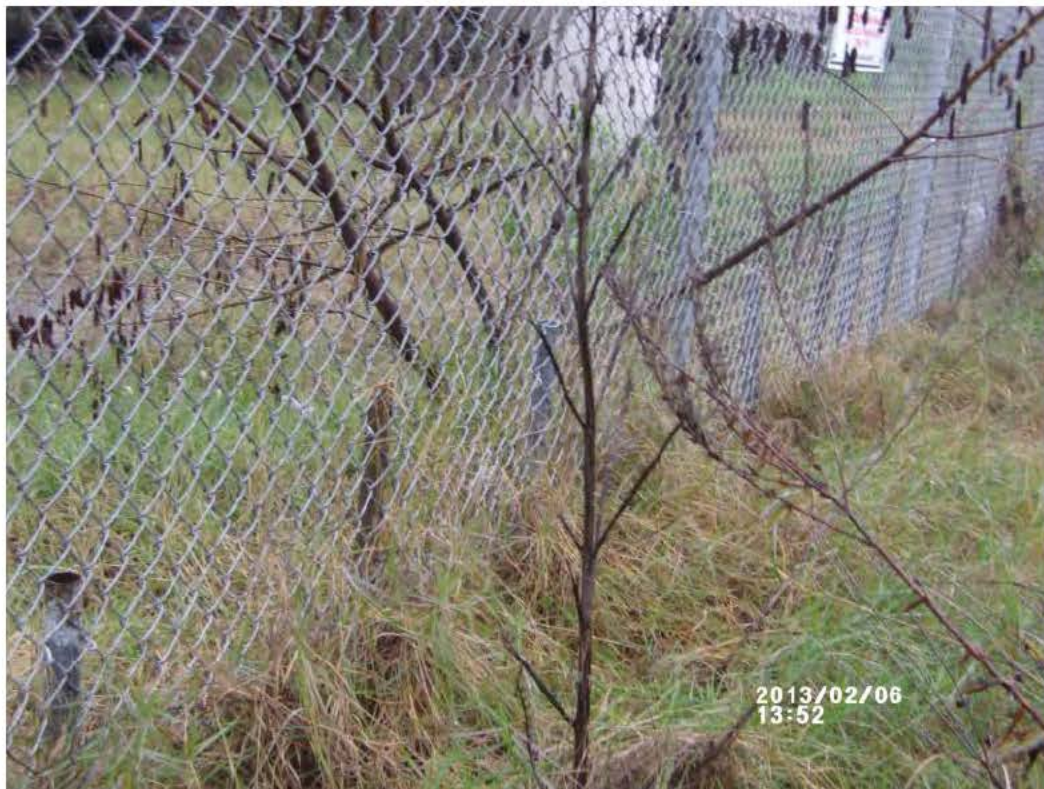
Photograph 4 – Added lower supports on adjacent panels to secure fence fabric and barb wire.

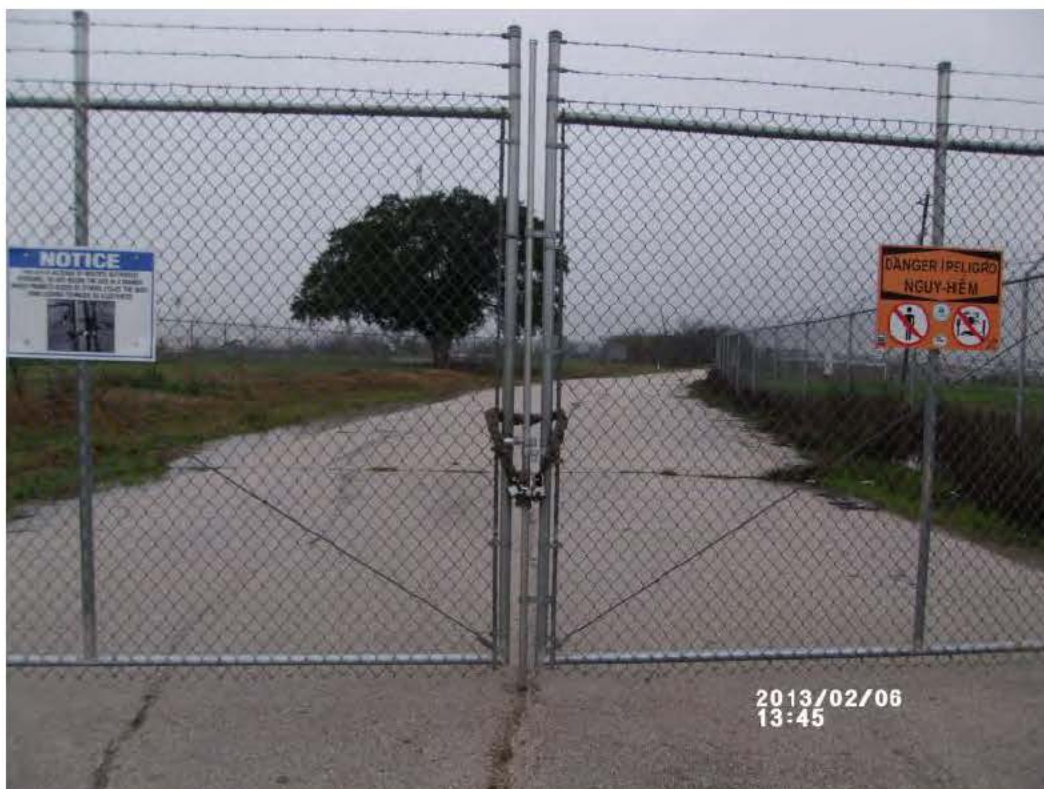
Photograph 5 – New gate center post installation, east bank. All fence maintenance actions complete.
